Assessment of Twenty-Eight (28) Trees  
At Sunrise Senior Living Facility, Redwood City (Proposed)  
(Multiple Residential and Commercial Lots)  
2915 El Camino Real  
Redwood City, California

Prepared for:

Sunrise Senior Living  
Attn: Ms. Jackie Dominguez  
7902 Westpark Drive  
McLean, VA 22102

Revised 10/25/2017

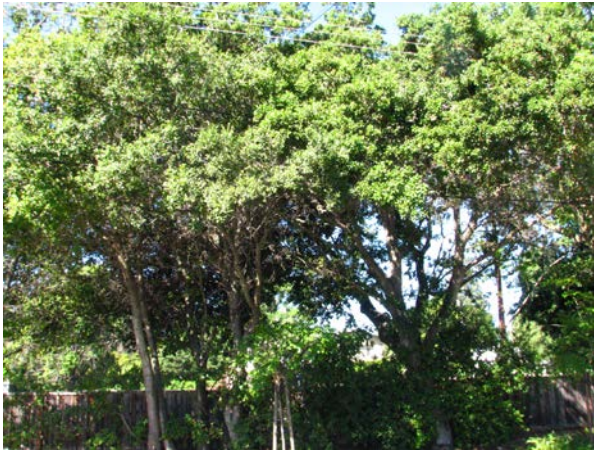
R to L  
6, 7, 8

6	coast live oak	<i>Quercus agrifolia</i>	est. 24	0	0	0	est. 24	Significant tree	35/45	75/75	75% good	mod to good				south west	south														Was pruned to clear overhead wires. New walkway base excavation work to occur at 10 feet from trunk edge. New building foundation cuts will be at 20 feet from trunk edge. Will need pruning to clear new building and also scaffold erection airspace for exterior finishing work. Storm drain pipe trench to encroach to 3 feet from trunk.	TB, RPZ, P.  Limit walkway base excavation to max. 2 to 4 inches cut depth. Keep storm drain pipe trench shallow cut at max. 2 inches cut depth below grade.

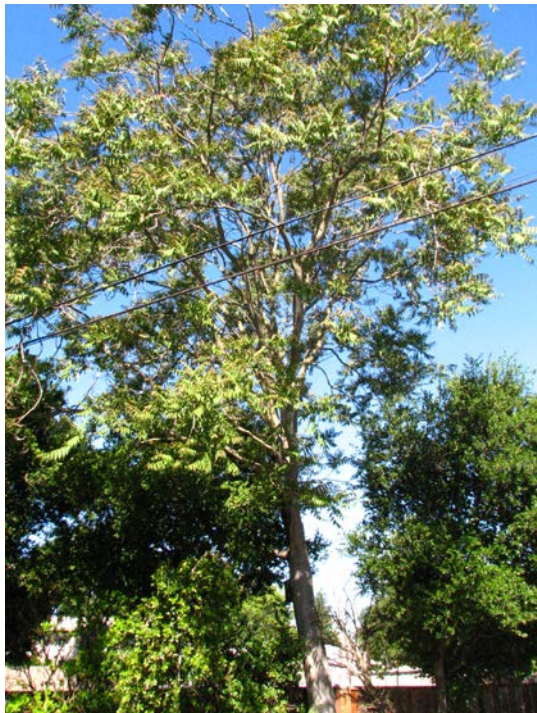
9

Tree #9 can either be retained or removed. Although the tree of heaven is typically considered a weak wooded, fast growing, short lived trash tree, specimens in good condition in terms of structure and vigor (such as this particular specimen #9) can be retained as shade trees for relatively long periods of time in the landscape. Some specimens of this species have been known to provide good site screening and shade value for many decades in and around the Bay Area peninsula area. As always, good maintenance practices are warranted, such as periodic monitoring for branch splitouts, regular irrigation application, etc. Per the September 2017 version of tree disposition sheet L-5, this tree is to be retained.

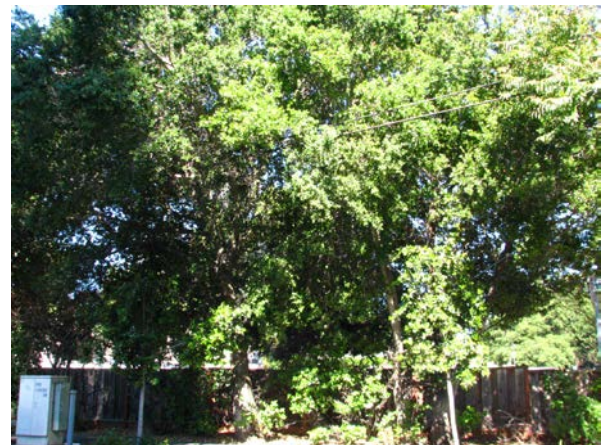
R to L  
10, 11,  
12

10	New pathway paver base section excavation and subgrade prep at 7 feet from trunk edge.	Prune south side of canopy to clear scaffold erection airspace.	Proposed storm drain pipe trench alignment will encroach to 4 to 5 feet from trunk.		
11	New pathway paver base section excavation and subgrade prep at 5 feet from trunk edge.	Prune south side of canopy to clear building footprint and scaffold erection airspace.			
12	New pathway paver base section excavation and subgrade prep at 6 feet from trunk edge.	Prune south side of canopy to clear building footprint and scaffold erection airspace.

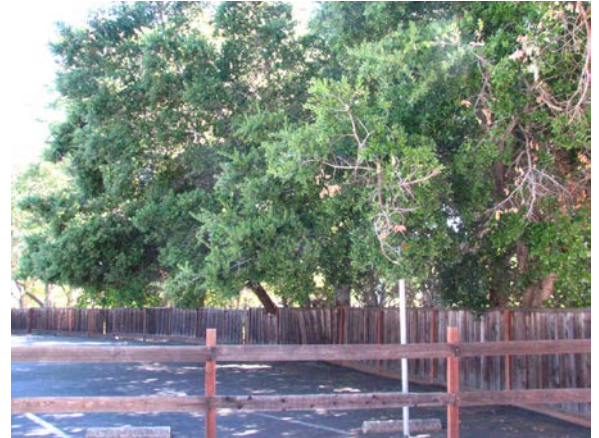
North view of oaks 10, 11, 12, 13, & 14 extend -ed south and west into the (e) lot.

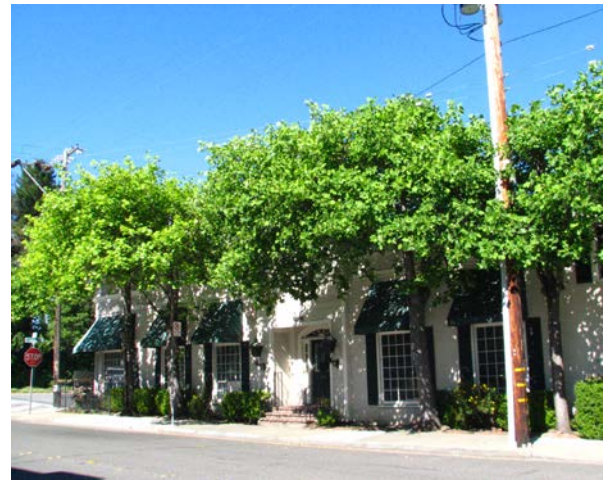
R to L 16, 17, 18

Trees #16, 17, and #18 are potentially retainable. However, considering the above-noted factors, it may be better to simply remove the trees and replace them with more desirable species that attain shorter ultimate heights such that the trees do not end up being pruned to clear the wires in the future. The landscape arborist of record (LAOR) on this project can be consulted to recommend appropriate replacement tree species, or WLCA can work with the LAOR to determine appropriate species. Per the September 2017 revised landscape plan and tree disposition sheet L-5, these trees are to be removed.

16	tulip poplar	<i>Liriodendron tulipifera</i>	17.5	0	0	0	17.5	Significant tree	25/30	70/45	57% fair	mod	X					X													X		Was topped to clear various overhead utility wires in the past. Tree is susceptible to various insect pests.  Root system extension westward is very limited, due to presence of existing building foundation. Root system expansion causing severe sidewalk slab displacement.	
17	tulip poplar	<i>Liriodendron tulipifera</i>	17.3	0	0	0	17.3	Significant tree	25/30	65/55	59% fair	mod	X					X													X		(Same as #16 above)	
18	tulip poplar	<i>Liriodendron tulipifera</i>	15.6	0	0	0	15.6	Significant tree	30/25	65/55	59% fair	mod	X					X													X		(Same as #16 above)

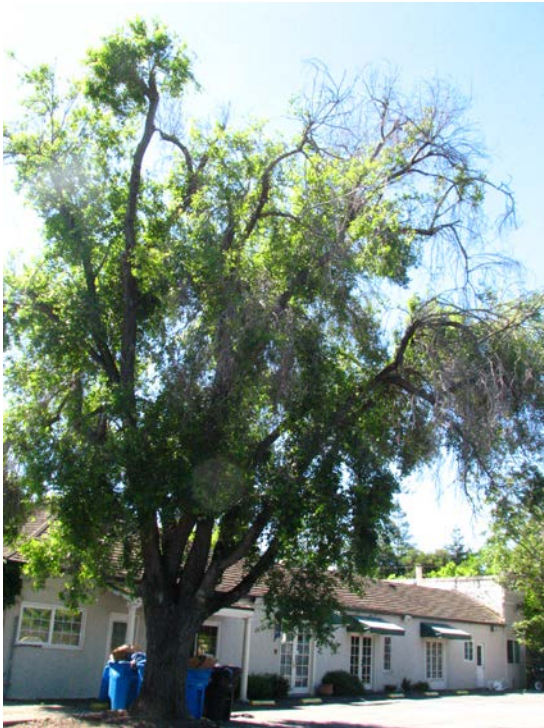
19	American elm	<i>Ulmus americana</i>	29.7	0	0	0	29.7	Significant tree	35/40	25/25	25% very poor	poor	X																		Twig and branch dieback throughout noted. Root crown decay noted. Tree is slated for removal due to conflicts with plan.		
20	tree of heaven	<i>Ailanthus altissima</i>	28.1	0	0	0	28.1	Significant tree	35/30	20/15	18% very poor	very poor	X																		Twig and branch dieback throughout noted. Root crown decay noted. Flux noted on bark. Assymetrical root plate noted. Tree is slated for removal due to conflicts with plan.		
21	American elm	<i>Ulmus americana</i>	43.5	0	0	0	43.5	Significant tree	45/45	40/30	35% poor	poor	X					X	X												Tree has been limbed up many times to clear the existing Bentley's restaurant parking lot stall areas. Tree exhibits multiple codominant mainstems with bark inclusions (structural defect). Tree to be removed due to conflicts with building footprint.

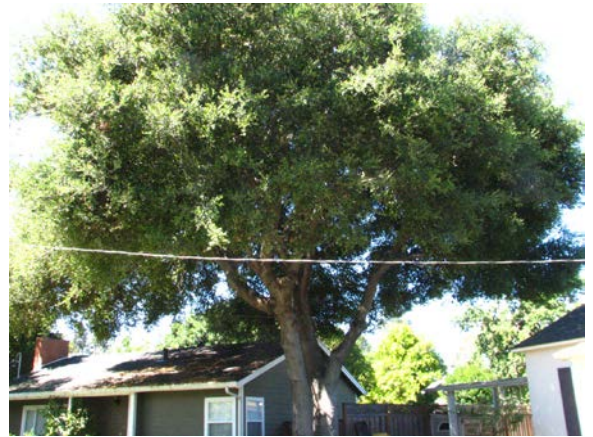
24, 25

Construction of the current proposed driveway area that extends west of the proposed new building footprint will require removal of large diameter coast live oaks #23, 24, and #25 in good, good, and fair overall condition respectively. These trees are proposed to be removed per sheet L-5 tree disposition dated September, 2017.

25	coast live oak	<i>Quercus agrifolia</i>	est. 26	0	0	0	est. 26	Significant tree	27/30	90/40	65% fair	good				west	west													X	Tree to be removed due to proposed asphalt driveway at the west side of the site. Note severe trunk lean off vertical to the west.		
26	California valley oak	<i>Quercus lobata</i>	est. 30	0	0	0	est. 30	Significant tree	35/35	75/65	70% good	mod																			Tree was not fully assessed due to lack of access to the lower trunk. Assume "good" overall condition rating. New walkway base prep will encroach to 1 or 2 feet from trunk edge. This walkway routing will probably have to be changed to farther offset from trunk, and the base cut depth limited to avoid killing the tree. New storm drain pipe route appears far enough from trunk (16 to 17 feet) that root loss will be minimized, though farther would be better (e.g. 20 to 25 feet offset from trunk).	TB, RPZ. Limit new walkway base excavation to 6 inches cut depth max. Move proposed walkway route to at least 4 to 5 feet offset from trunk edge. Realign the proposed storm drain pipe trench if possible to 20 feet or more from trunk edge.

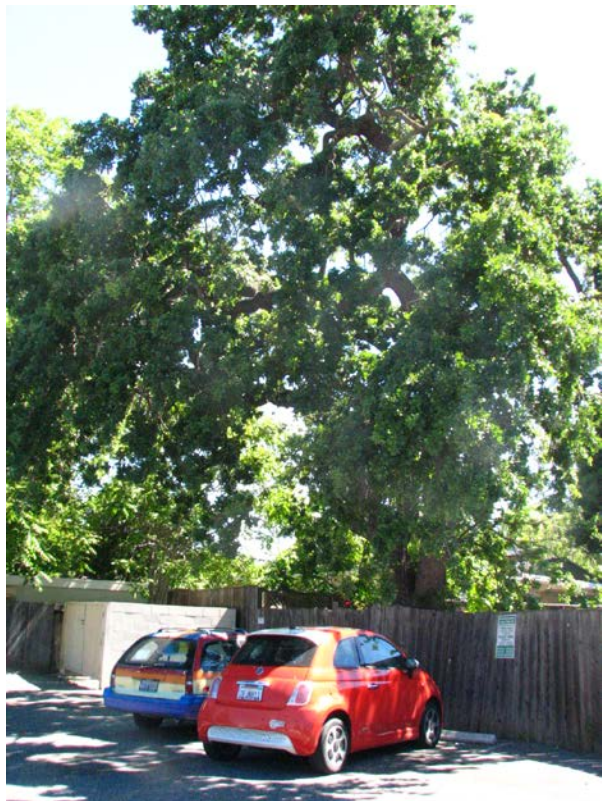
Tree Being Retained	Issue 1	Issue 2	Issue 3	Issue 4	Issue 5
26	New pathway paver base section excavation and subgrade prep at 1 to 2 feet from trunk edge.	New storm drain pipe trench at 16 to 17 feet from trunk.	Prune to clear new pathway airspace as needed.		
27	New pathway paver base section excavation and subgrade prep at 8 feet from trunk edge.				
28	New pathway paver base section excavation and subgrade prep at 8 feet from trunk edge.

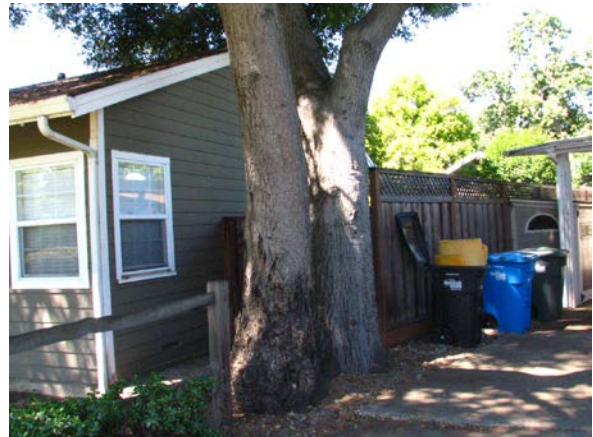
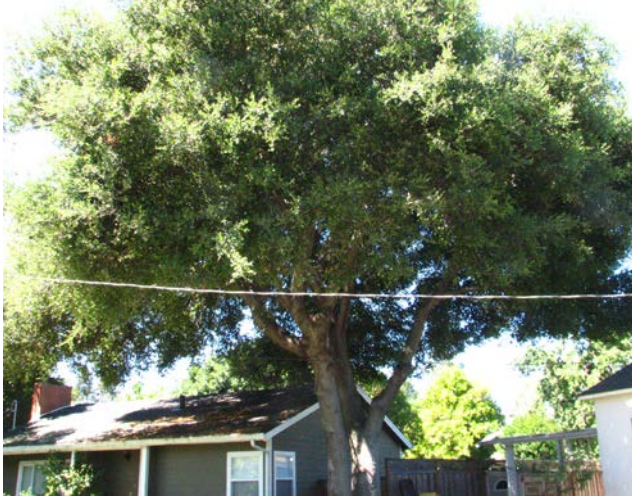
R to L  
27, 28

27	coast live oak	<i>Quercus agrifolia</i>	30.5	0	0	0	30.5	Significant tree	50/50	90/70	80% good	good				south west															Note root extension to south may be severely limited due to presence of existing house foundation 4 or 5 feet south of trunk, but this cannot be verified. New walkway will be roughly 8 feet from trunk, in the area where an older residence foundation will be demolished (expect zero root extension in this area, though roots may still be present if they somehow plunged under the older foundation and grew southward).	TB, RPZ, Do not renovate driveway to the north of trunk, as this could cause severe root loss and death of the tree.	
28	coast live oak	<i>Quercus agrifolia</i>	30.3	0	0	0	30.3	Significant tree	30/30	75/60	67% fair	good	X		X	south east															Sycamore bark moth larvae feeding causing severe wood tissue necrosis in lower trunk area.  Root expansion causing severe displacement of the existing driveway to north (neighbor property).  As noted above, root extension to south is limited due to existing house to be demolished. However, WLCA still recommends keeping all utilities offset from trunk at least 15 to 20 feet.	TB, RPZ. Do not renovate driveway to the north of trunk, as this could cause severe root loss and death of the tree.
