From: Lisa Ketcham <lisa.ketcham@comcast.net>
Sent: Wednesday, January 04, 2017 10:11 PM
To: Planning_Commission
Cc: Renee.Ananda@coastal.ca.gov; Camille Leung
Subject: PLN2016-00014, new SFD at 365 Miramar Dr - PC Jan 11

From: Lisa Ketcham [<mailto:lisa.ketcham@comcast.net>]
Sent: Sunday, December 18, 2016 1:42 PM
To: Camille Leung <cleung@smcgov.org>; Dennis Aguirre <daguirre@smcgov.org>
Cc: Renee.Ananda@coastal.ca.gov
Subject: Re: PLN2016-00014, new SFD at 365 Miramar Dr - Neg/Dec

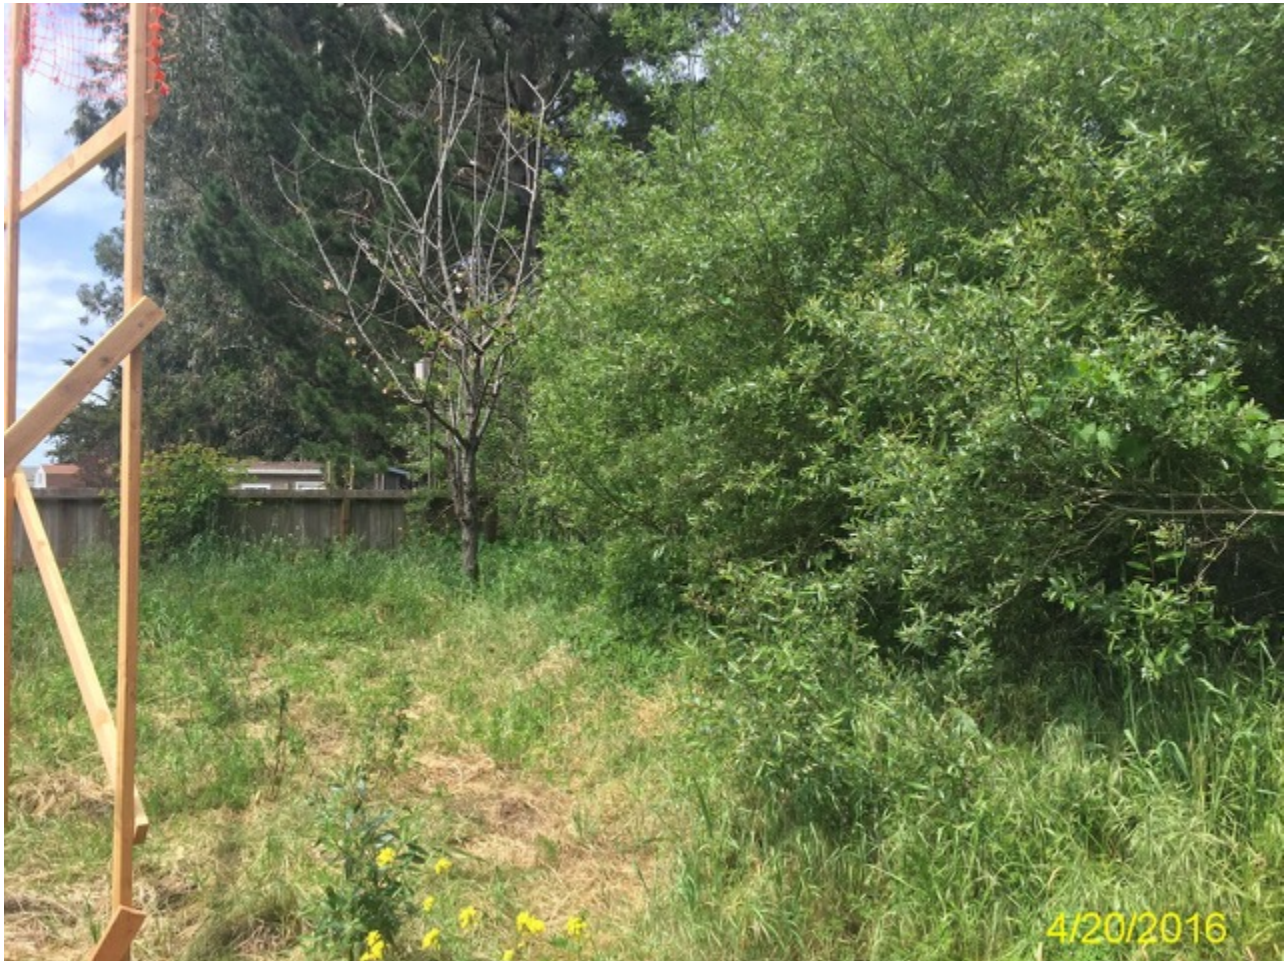
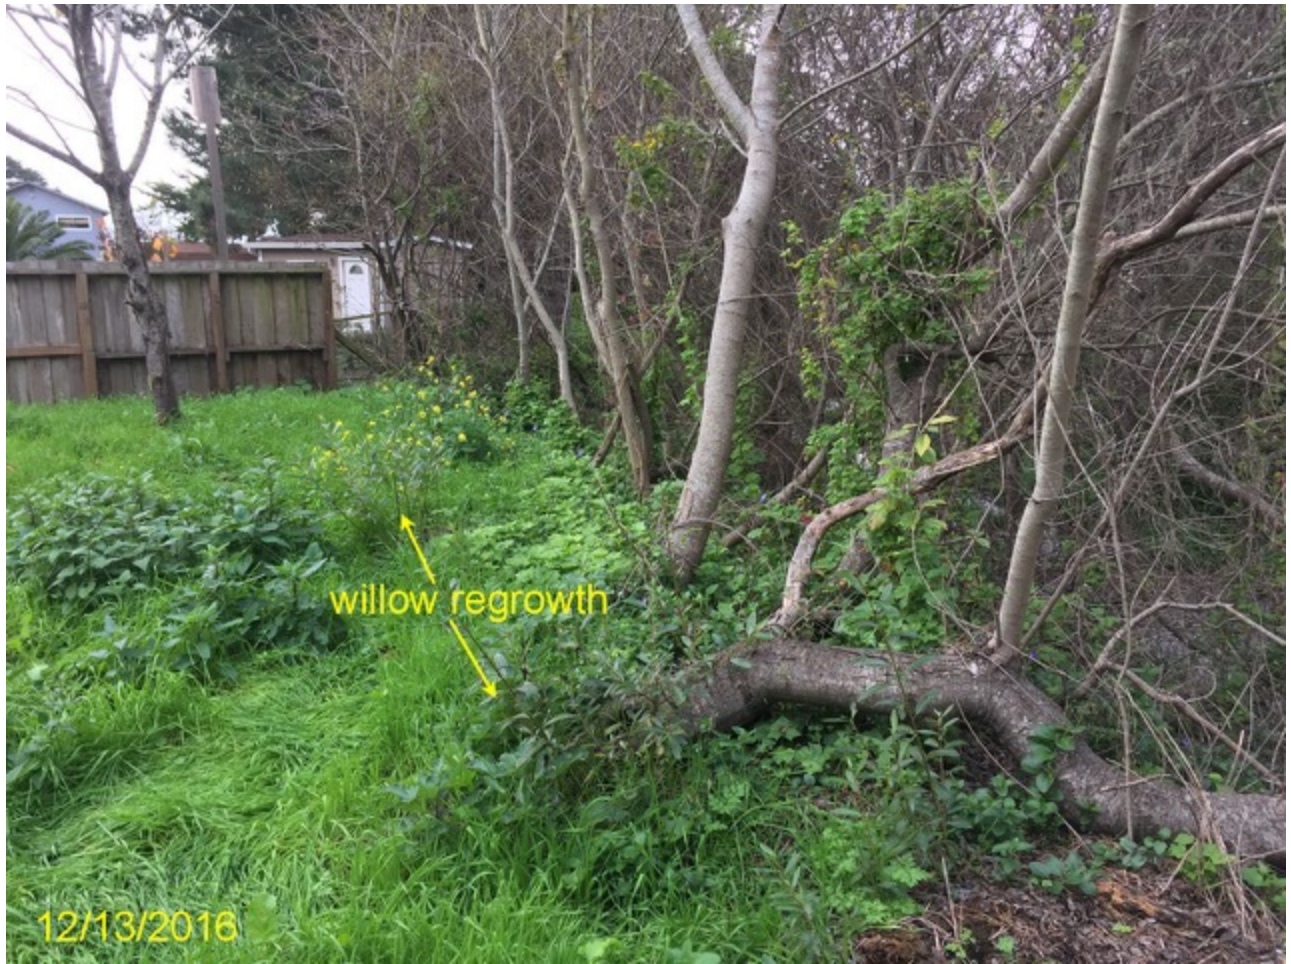
Sometime last summer, the arroyo willow riparian habitat was severely cut back, away from the house site, as seen in the attached before & after photos. Bare willow trunks are now exposed with all side branching removed. Ground level regrowth from cut trunks can be seen at arrows. Landmarks are the neighbor fence, and the rear landscape tree marked on the site plan to remain.

Despite the effort to move the dripline of the protected willows to favor the development, the 30-ft riparian setback cannot retreat farther than the actual location of the row of willow trunks on level ground at top of slope, and not as mapped on the site plan half-way or more down the bank of the arroyo.
