Assessment of Twenty-Eight (28) Trees  
At Sunrise Senior Living Facility, Redwood City (Proposed)  
(Multiple Residential and Commercial Lots)  
2915 El Camino Real  
Redwood City, California

Prepared for:

Sunrise Senior Living  
Attn: Ms. Jackie Dominguez  
7902 Westpark Drive  
McLean, VA 22102

Revised 10/25/2017

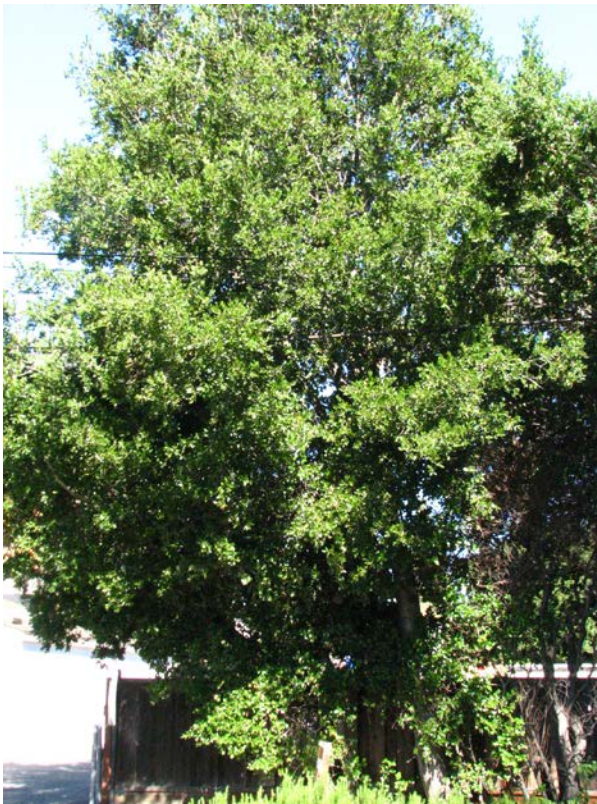
13, 14

North view of oaks 10, 11, 12, 13, & 14 extend -ed south and west into the (e) lot.

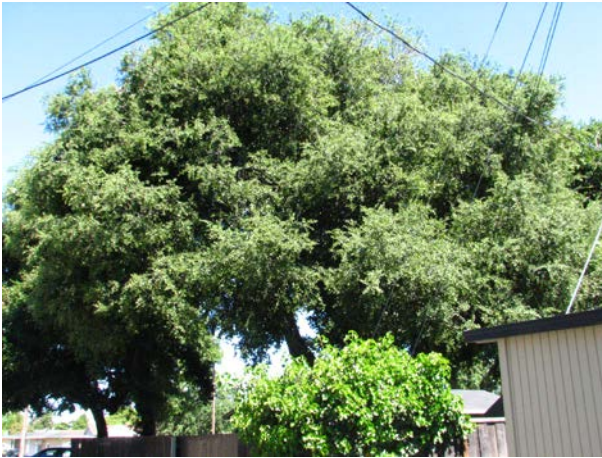
23

Construction of the current proposed driveway area that extends west of the proposed new building footprint will require removal of large diameter coast live oaks #23, 24, and #25 in good, good, and fair overall condition respectively. These trees are proposed to be removed per sheet L-5 tree disposition dated September, 2017.
